TECHNICAL SERVICE BULLETIN

New CARQUEST Improved Connector and Pigtail for GM Fuel Pump Modules

TSB-1106-01_CQ

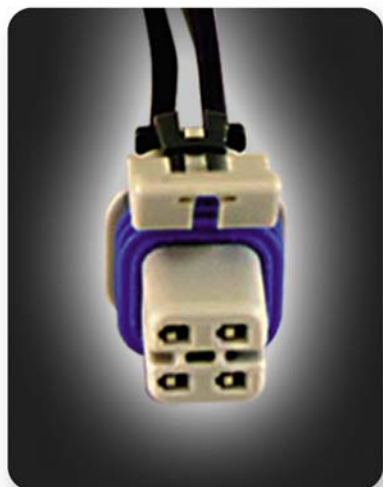
OLD VEHICLE HARNESS SOLD SEPARATELY

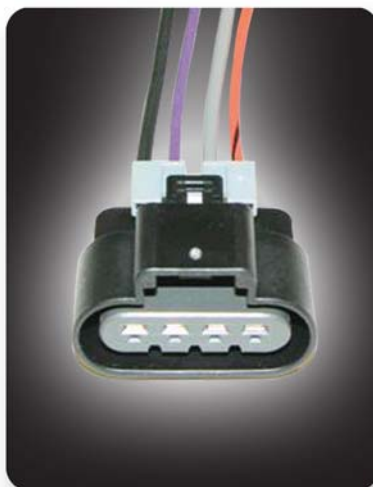
NEW VEHICLE HARNESS INCLUDED WITH FUEL PUMP MODULES

Fuel pump modules with the improved 4-pin connector require vehicle harness replacement. One of the five application-specific, color-coded vehicle wiring harnesses is included with every pump that uses the new connector.
