PRODUCT INFO

NEWS ABOUT CARQUEST ENGINE AND TEMPERATURE CONTROLS

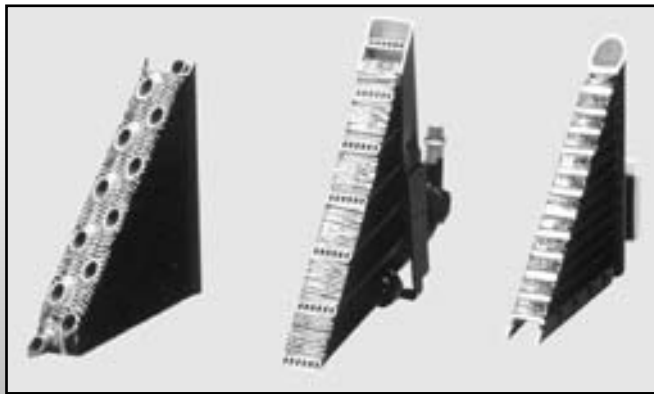
It doesn't take much to plug a condenser, and this

will probably destroy the compressor. The tube openings in a parallel flow or serpentine condenser may not be much larger than the head of a ballpoint pen. Whenever the compressor is replaced, the condenser must be flushed under pressure, using only 141B or Dura Flush. Pressurize the flush with shop air and blow it through the condenser, or use a power flusher that pulsates the flush. Closed-loop flushing systems are usually not effective unless an in-line filter is installed first. Also be sure to remove all of the flushing solvent from the system when finished. This is a must since any residue solvent will take up vital space needed for refrigerant, and can also contaminate the new compressor lubricant.

Flushing won't always cure a plugged condenser. If the high side gauge connector is

located past the condenser on the high side liquid line, it can disguise the fact that a plugged condenser exists. The best location is between the compressor and the condenser, and an even more effective method is to have another connection after the condenser to determine a drastic pressure drop.

If an FX15 compressor equipped system dies from "Black Death" and leaves a gooey substance in its wake, or if a failed GM DA6 unit peels off the piston rings, sending the particles of ring material through to the condenser, replace the condenser (or else warn your customer that more trouble may be on its way). The replacement compressor can sometimes run for a short time, but may experience premature clutch failure due to the elevated pressures. Without flow, the compressor is pumping with no place for the pressure to go. This elevated pressure will soon overwork and overheat the compressor and/or clutch.

Check the pressure in the condenser, or use a pyrometer to check the temperatures across the condenser surface. A good A/C system will have up to a 60 degree drop between the condenser inlet and outlet. If you encounter a drop larger than 60 degrees, try flushing it first, and then check the inlet and outlet temperatures again. If the drop remains high, the condenser should be replaced.

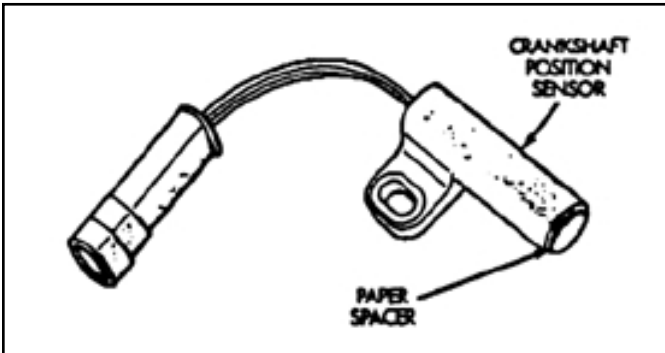
On Chrysler 4.0L engines with automatic transmissions, the crankshaft position sensor uses a

single slotted hole to adjust its depth. A self-adhesive paper/cardboard type spacer is attached to the bottom of the sensor to set this depth. After the sensor has been installed and the engine has been started, this temporary spacer will be sheared off.

When installing a replacement sensor, be sure the paper/cardboard spacer has been stuck on the bottom of the sensor. This spacer must be installed; if it isn't, the sensor will be damaged once the engine is started. If the original sensor is being reinstalled (such as with transmission or flywheel removal), clean the bottom of the sensor, obtain a new spacer and remove the paper backing; then install the self-adhesive side to the bottom of the sensor.

For proper depth adjustment, the sensor mounting bolt should first be installed finger-tight. Then gently seat the sensor until the paper spacer contacts the outer edge of the flywheel, and tighten the sensor mounting bolt to 60 in.lbs. Then connect the electrical connector, and install the wire clip and the mounting nut.

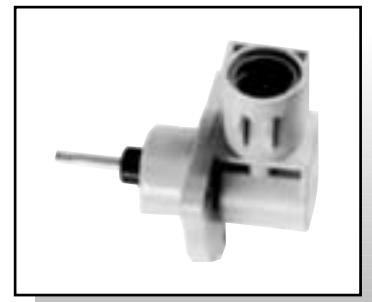
In some cases, when Ford supersedes an EGR valve, the original EGR valve position sensor will not fit onto the new valve because some EGR valves have threaded studs, while

others have threaded holes. Whenever you replace an EGR valve for a Ford application, check on whether a new EGR position sensor is also needed. This part should be checked for proper operation when EGR valve service is performed.
